## COMPARISON OF ACOUSTIC AND ELECTRICAL IMAGE LOGS FROM THE COSO GEOHERMAL FIELD, CA

NICHOLAS C. DAVATZES AND STEVE HICKMAN

U.S. Geological Survey, Menlo Park, CA, 94025  
e-mail: [ndavatzes@usgs.gov](mailto:ndavatzes@usgs.gov)

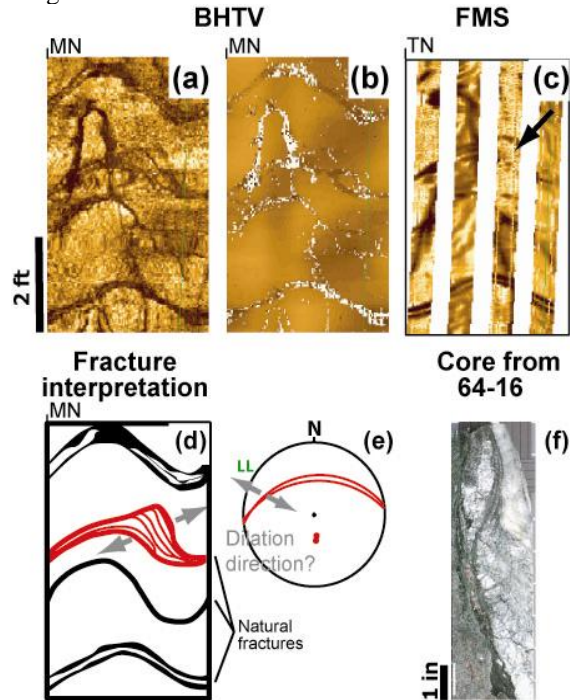
Figure 2: Natural fractures in BHTV (a) amplitude, (b) travel time, and (c) FMS image logs from a measured depth of 9857 ft. The BHTV and FMS logs are oriented with respect to magnetic North (MN) and true (TN), respectively, with a magnetic declination at this site of 14°E. Each image progresses from North, then through East, South, West, and back to North. (d) Sketch of natural fracture geometry and texture of fault rock seen in Figures 1a through 1c. (e) Stereogram of natural fracture colored red in (d). The gray arrows indicate the dilation direction inferred from the texture of the natural fracture. (f) Similar geometry to (a-d) is visible in core from 990 ft measured depth in well 64-16 (Figure 1). In this figure and all subsequent figures brighter images in the BHTV amplitude indicate greater signal strength and in two-way travel time indicate shorter times. Brighter images in FMS indicate lower conductivity. White in travel time data indicates signal loss.

In well 58A-10 both types of image logs revealed natural fractures with varying thickness or slightly non-planar geometry (Figure 2). For example, the fracture visible at center-depth in Figures 2a, b, and c has a large asperity along its surface. The basal trace is the most nearly sinusoidal, and successively less planar segments (less sinusoidal) in the un-wrapped image are associated with the “descending” limb of the sinusoid. The shape of the asperity suggests successive opening or shearing along multiple surfaces, possibly representing multiple crack-seal events (Figure 2d). Either geometry indicates apparent extension consistent with oblique normal slip across this fracture (Figure 2e). This geometry is similar to core from well 64-16 (Figure 1) from the East Flank of the field (Figure 2f), which contains multiple shear zones of foliated chlorite-smectite surrounded by brecciated host rock.

The BHTV clearly reveals fine scale geometry of the structure in Figure 2. The FMS log reveals less of the internal structure, but indicates variation in the conductivity of the fracture where more resistive zones are bright and more conductive zones toward the margins of the fracture are dark. In the BHTV image the locations corresponding to higher conductivity coincide, with signal loss (white areas in the travel time data) indicating a rough or recessed surface. Both the variation in the loss of data and varying conductivity indicate heterogeneous physical properties within the fracture that might be related to porosity production accompanying slip, the distribution of minerals with different conductivity,

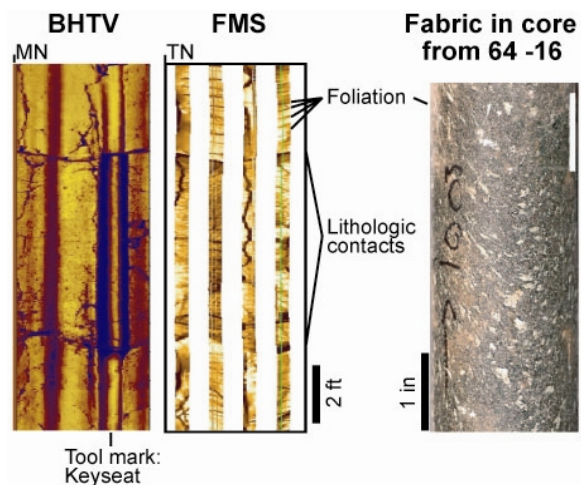
Figure 3: BHTV amplitude and FMS image logs of intervals containing two transitions in rock type indicated by changes in image log character and changing depth of wear caused by rubbing of the drill string (tool marks). The upper rock type contains a foliation, which is only visible in the FMS log and is similar to fabric visible in core from well 64-16.

Both image logs show changes in image log character, image quality, and pipe-wear along the borehole wall that occur across abrupt near-planar transitions. Transitions that separate large (10's of m) depth intervals of distinct image log character coincide with changes in rock type indicated by the cuttings log. Smaller depth intervals distinguished by distinct image log character in both BHTV and FMS (Figure 3) are not associated with distinct changes in cuttings mineralogy. However, as shown here, the depth of pipe-wear visible in BHTV images often

The depth interval above the first rock type transition at the top of the images in Figure 3 is also distinguished by a pervasive set of sub-parallel sinusoids only visible in the FMS image. This type of

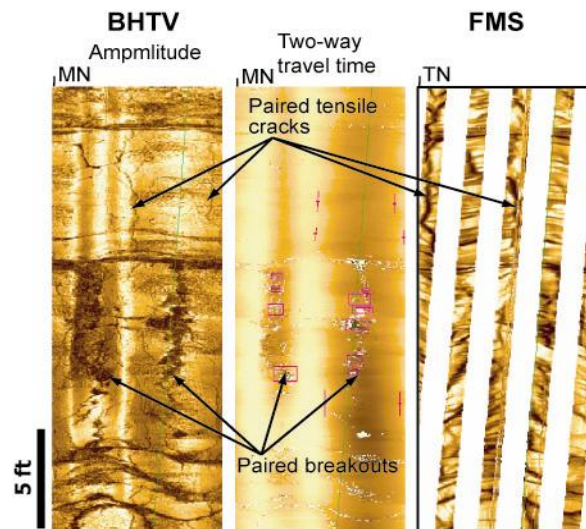
Figure 6: BHTV amplitude and two-way travel time, and FMS image logs of intervals containing borehole wall tensile fractures and breakouts.

Borehole wall tensile fractures are common in both BHTV and FMS image logs of well 58A-10 (Figure 6). We identified this type of borehole wall failure in logged intervals where tensile fractures occurred as paired vertical lineations 180° apart or as an echelon lineations 180° apart.

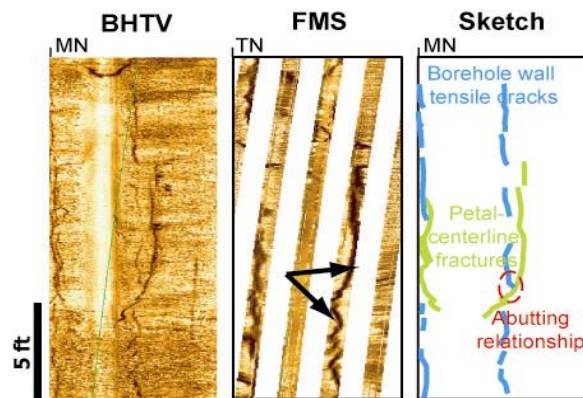
Figure 8: BHTV and FMS image logs of classic borehole tensile cracks (blue) abutting against a petal-centerline fracture (green). The abutting relationship circled in red in the sketch confirms that the petal-centerline fractures formed before the tensile failure of the borehole wall. This relationship is not visible in the FMS image, where one could easily mistake a petal-centerline fracture for a true borehole wall tensile crack (arrows).

In FMS images, pairs of centerline fractures are unlikely to be completely imaged because they need not form 180° apart and FMS pads are spaced at 90° increments (although greater coverage in other electrical imaging tools will reduce this limitation). As a result, centerline fractures spaced less than 180° could be misinterpreted as classic borehole wall tensile fractures (FMS image in Figure 8). Similarly, petal fractures might mistakenly appear to be parts of

Figure 8 illustrates an example where such confusion is likely in the FMS. This example also reveals an abutting relationship visible in BHTV log that confirms that classic borehole wall tensile fractures form after petal fractures.

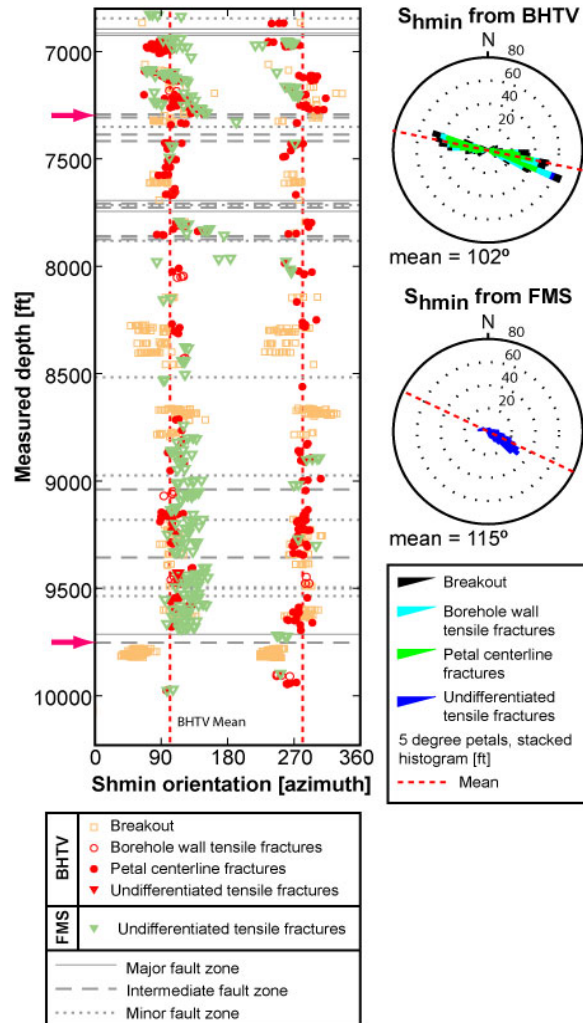
Figure 9: Orientation of  $S_{hmin}$  as a function of depth. The means  $S_{hmin}$  orientation shown as dashed red line in the depth section is derived only from analysis of the BHTV logs. Red arrow shows location of a significant stress rotation possibly related to slip on one or more active faults observed at this depth.

Analysis of breakouts, pairs of borehole wall tensile cracks and pairs of petal-centerline fractures from the BHTV logs (Figure 9) indicates that  $S_{hmin}$  near well 58A-10 is oriented along an azimuth of  $102^\circ \pm 18^\circ$ . A large proportion of the tensile fractures evident in these BHTV image logs are interpreted as petal-centerline fractures. Our analysis of the BHTV data shows that petal-centerline fractures provide comparable stress orientations to breakouts and borehole wall tensile fractures (summarized in Figure 9). In contrast, the FMS data shows considerably more scatter and fewer picks because of the poor azimuthal coverage of the borehole wall and the inability to distinguish petal-centerline fractures from borehole wall tensile cracks. The FMS mean  $S_{hmin}$  direction also departs by 13° from the BHTV analysis. Careful calibration (not presented here) between the logs demonstrates that they are well oriented with respect to each other. Thus, this difference is probably a result of the sampling bias resulting from FMS pad spacing and the much smaller population sampled (including lack of breakouts).

The depth distribution of induced structures visible in the BHTV data also shows one prominent stress rotation at ~9750 ft near the locations of several large faults visible in the image logs (arrow in Figure 9). Other less prominent stress rotations, such as the potential rotation at ~7350 ft, are evident, but do not stand out as clearly from the scatter. These rotations
